**Inspection reference: 062817KG1**

## **Inspection Report**

Inspection Address:  
**1724 Painted Bunting Cir  
Palm Harbor, FL 34683**

Inspection Date/Time:  
**June 28, 2017**

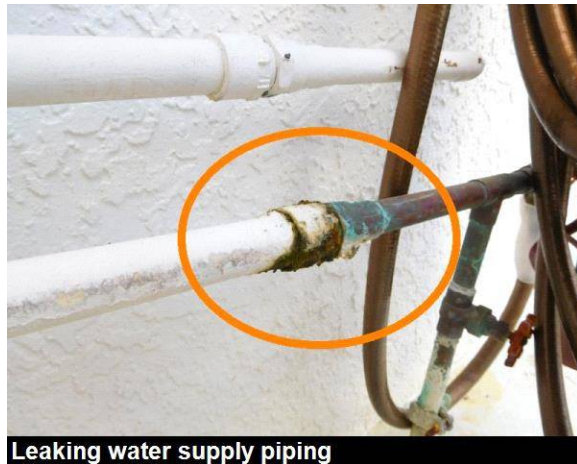
**Leaking water supply piping**

The main water supply piping at the west side of the house that feeds the water softener system is leaking where the PVC piping attaches to the copper piping. Further evaluation is needed by a licensed plumbing contractor to make proper repairs to leaking piping.

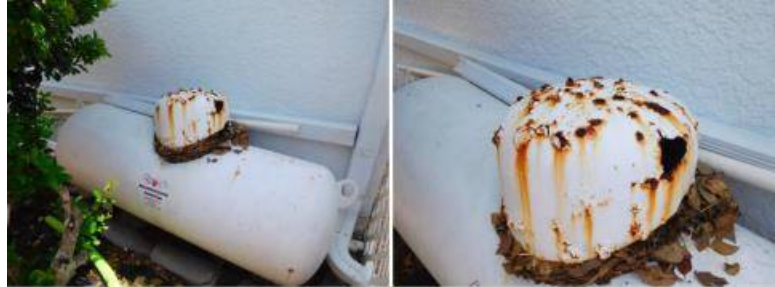
At the LP tank at the southwest corner of the house the lid that protects the regulator valve is badly rusted and deteriorated. Further evaluation will be needed by the servicing LP gas contractor to fully inspect tank for defects and replace lid.

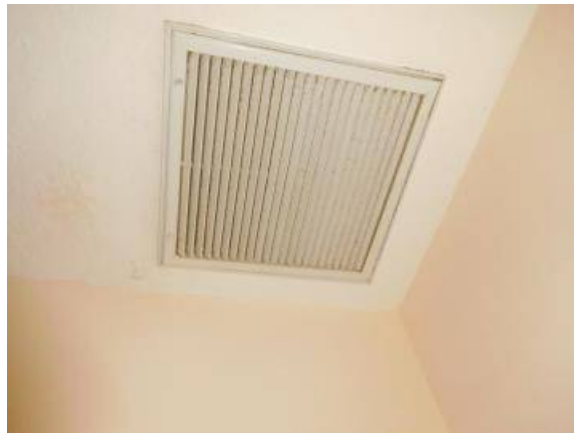
The air handler filter is not installed at the return air vent. Further evaluation will be needed by a licensed air conditioning / heating contractor to install proper sized filter.

The air handler filter is not installed at the return air vent. Further evaluation will be

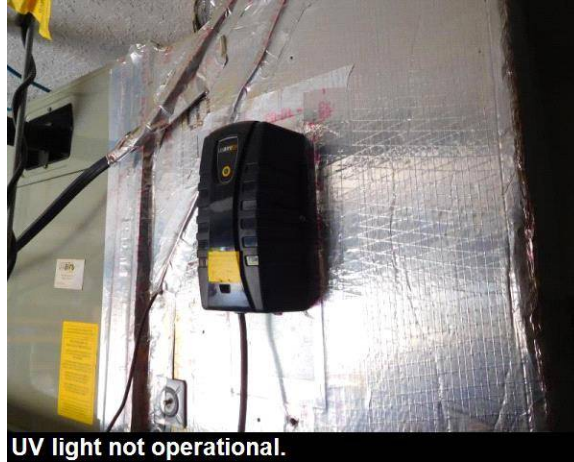
**UV light not operational.**

The ultra violet lighting system inside of the air handler unit was found not operational. Further evaluation is needed by a licensed Air Conditioning and Heating contractor to make proper repairs.

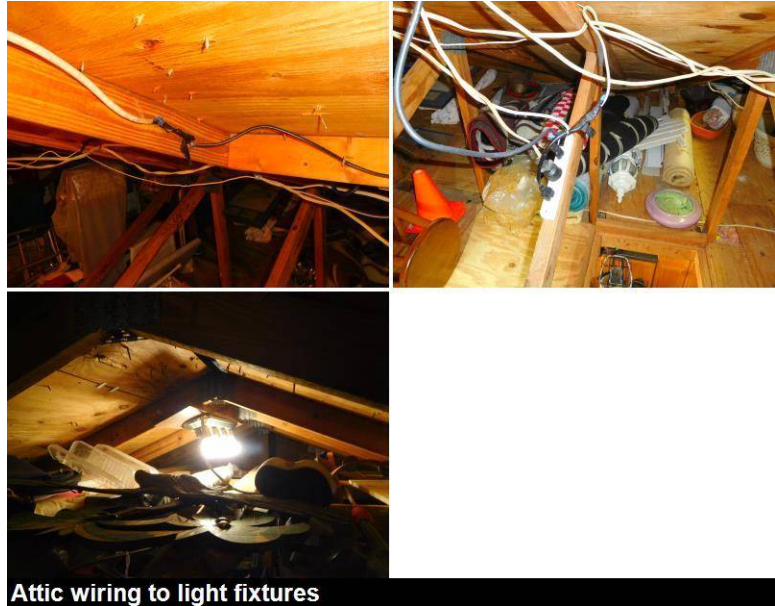
**Attic wiring to light fixtures**

The branch electrical wiring feeding the overhead lighting system in the Attic area over the garage is not properly installed as a number of exposed electrical joints were found and household extension cord is feeding fixtures. Further evaluation is needed by a licensed electrical contractor to make proper electrical repairs to add lighting system.

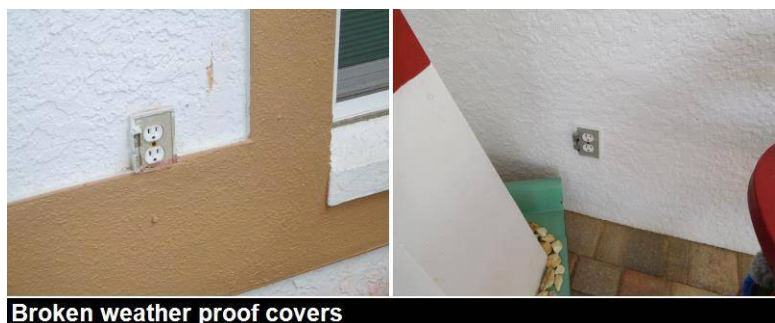
**Broken weather proof covers**

The 120 volt exterior weather proof covers on the north and south sides of the house are broken. Further evaluation will be needed by a licensed electrical contractor to make proper cover replacement.

The 120 volt exterior weather proof cover on the north and south sides of the house are broken. Further evaluation will be needed by a licensed electrical contractor to make proper cover replacement.

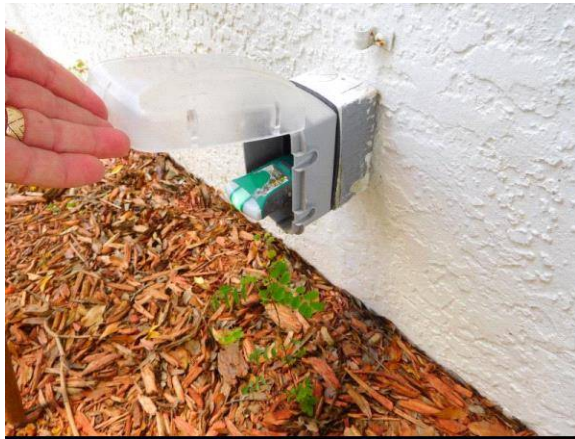
The exterior 120 volt outlets were found not GFCI protected as is required by the National Electrical Code since 1971. Further evaluation is needed by a licensed Electrical Contractor to properly install correct outlets.

**Typical missing GFCI protective outlet**

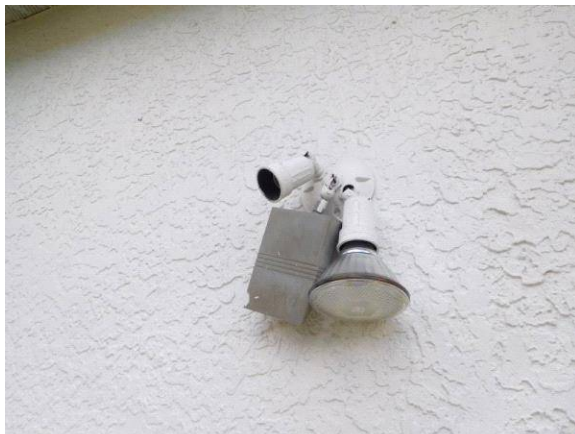
**Damaged flood light fixture**

The exterior flood light fixture at the side garage door is broken. Further evaluation will be needed by a licensed electrical contractor to make proper fixture replacement.

The exterior flood light fixture at the side garage door is broken. Further evaluation will

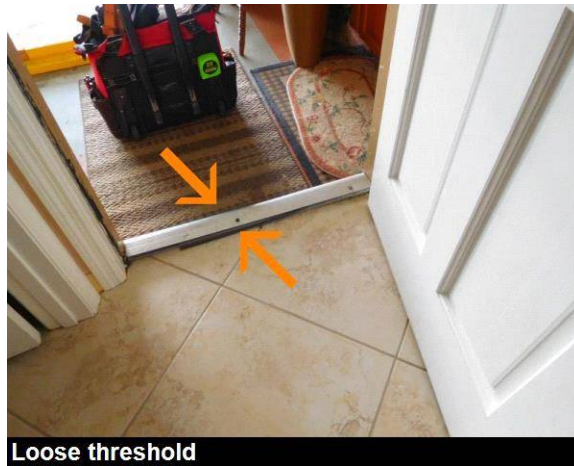
The threshold at the garage hallway door is loose preventing a weather tight seal. Further evaluation will be needed by a licensed general contractor to make proper repairs.

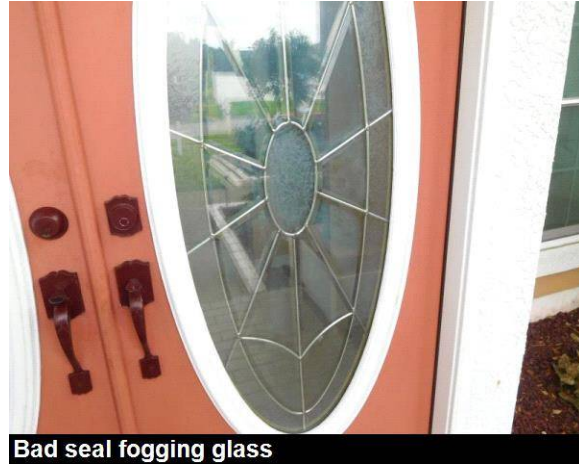
**Bad seal fogging glass**

At the front french doors the seal between the double glass decorative window pane's has been jeopardized causing the argon gas to escape between the glass pane's or the UV seal coating has become jeopardized. This condition has allowed moisture to buildup between window pane's causing fogging and staining. A licensed window contractor should make further evaluation for proper glass replacement.

At the front french doors the seal between the double glass decorative window pane' s has been jeopardized causing the argon gas to escape between the glass pane' s or the UV seal coating has become jeopardized. This condition has allowed moisture to buildup between window pane' s causing fogging and staining. A licensed window contractor should make further evaluation for proper glass replacement.

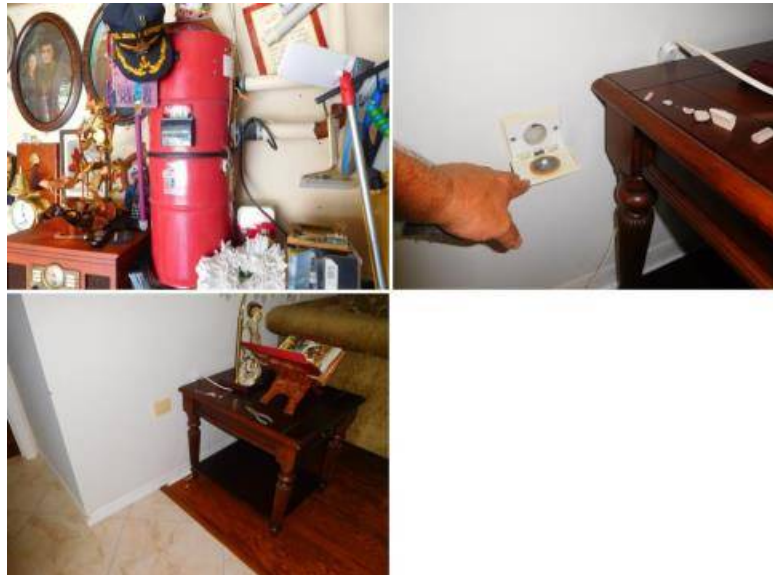
The vacuum port on the East living room wall for the central vacuum system is plugged with small rocks and Pebbles. Further evaluation is needed buy a licensed Appliance contractor to properly unclog central vacuum system.

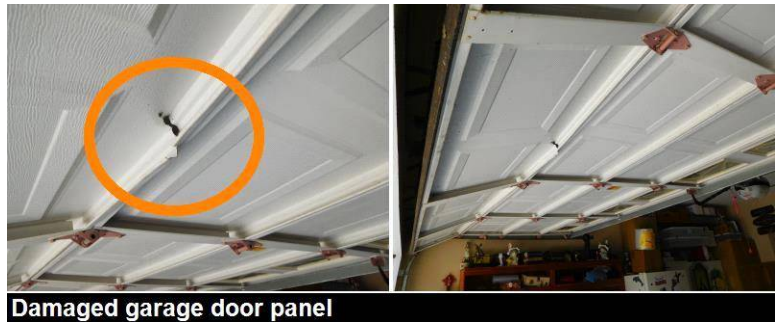
**Damaged garage door panel**

The lower metal overhead garage door panels is cracking and splitting apart. This condition is causing the door to sag and bow downward when open and will in time jeopardize the structural strength of the overhead door panels. Further evaluation is needed by a licensed garage door contractor to make proper panel replacement or possible hole door replacement.

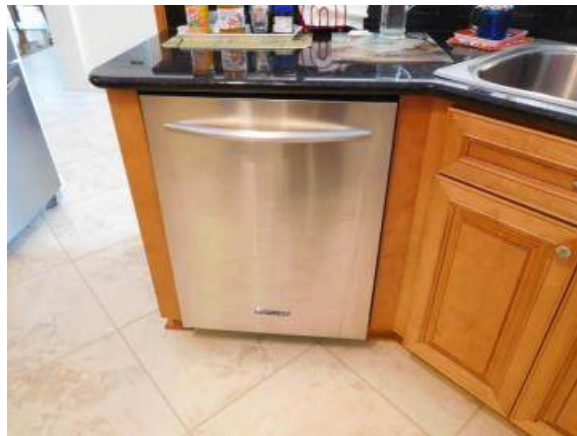
The dishwasher is not operational as it does not respond to control settings. Further evaluation is needed by a licensed appliance contractor for proper repairs.

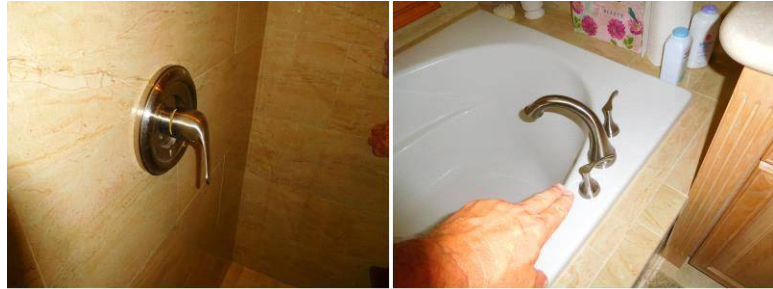
**Loose handles**

The operation handle at loose at the shower faucet and at the cold water faucet on the tub. Further evaluation will be needed by a licensed plumbing contractor to make proper repairs.

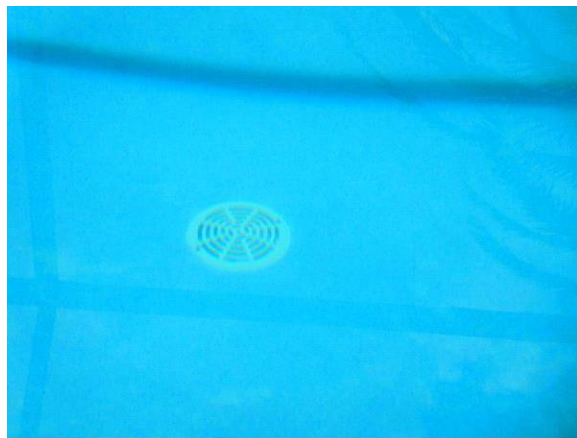
**Drain cover replacement suggested**

The pool center drain cover does not meet the new pool code requirements of anti-entrapment pool drain covers. Older drain covers have had a long history of causing injury's. Often time small ( younger ) children will get trapped at the older drain cover. It is strongly suggest that pool drain cover be upgraded to present code requirements. Further evaluation is needed by a licensed Pool Contractor to make proper cover replacement.

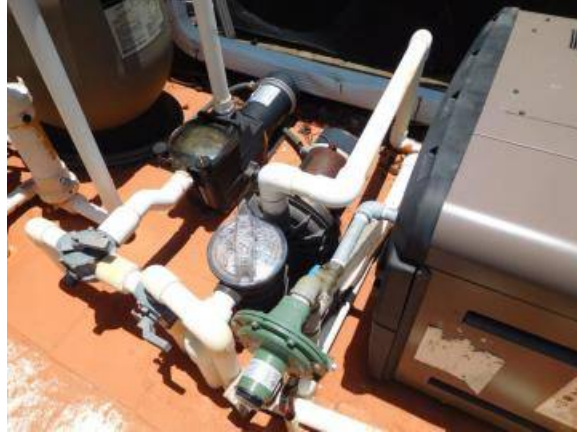
The SPA pump motor is not operational. Further evaluation is needed by a licensed pool contractor to make proper pump replacement.

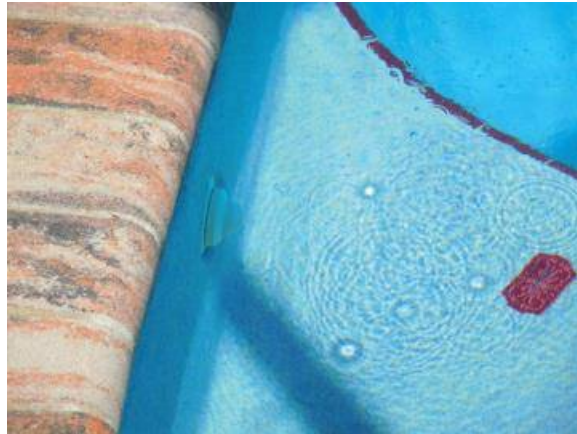
Air bubbles were noted at the supply jets this is a indication that the pumping system is sucking in air from some location. Further evaluation is needed by a licensed Pool Contractor to determine the source of the air bubbles and make proper repairs.

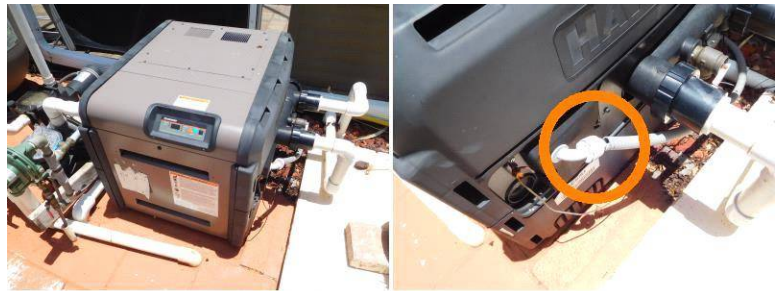
The gas pool heater is not operational as it would not respond to control settings. Further evaluation is needed by a licensed pool contractor to make proper repairs or possible replacement.

The protective electrical conduit feeding the pool heater has come loose at the connector. Further evaluation will be needed by a licensed electrical contractor to make proper repairs.

**Heater not operational / Loose conduit**

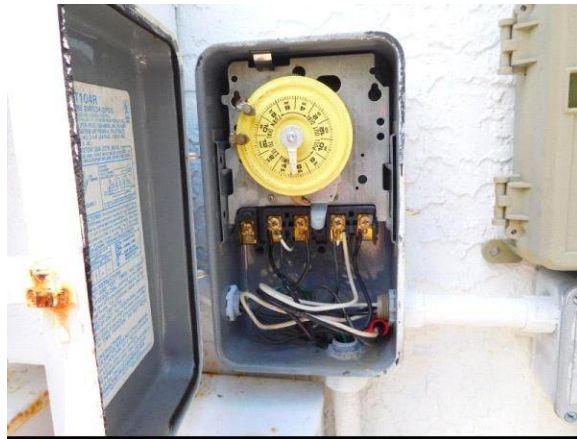
**Missing protective cover**

Terminal protector cover is missing from inside of the pool motor timer. SAFETY HAZARD!
